FIRE RESISTANCE TESTING OF BULKHEAD AND DECK
PENETRATIONS(U) COAST GUARD RESEARCH AND DEVELOPMENT
CENTER GROTON CT D E BEENE ET AL. OCT 85 CGR/DC-5/85
USCG-D-33-85

Report No. CG-D-33-85

FIRE RESISTANCE TESTING OF BULKHEAD AND DECK PENETRATIONS

D.E. BEENE, JR.
and
J.H. HOWES

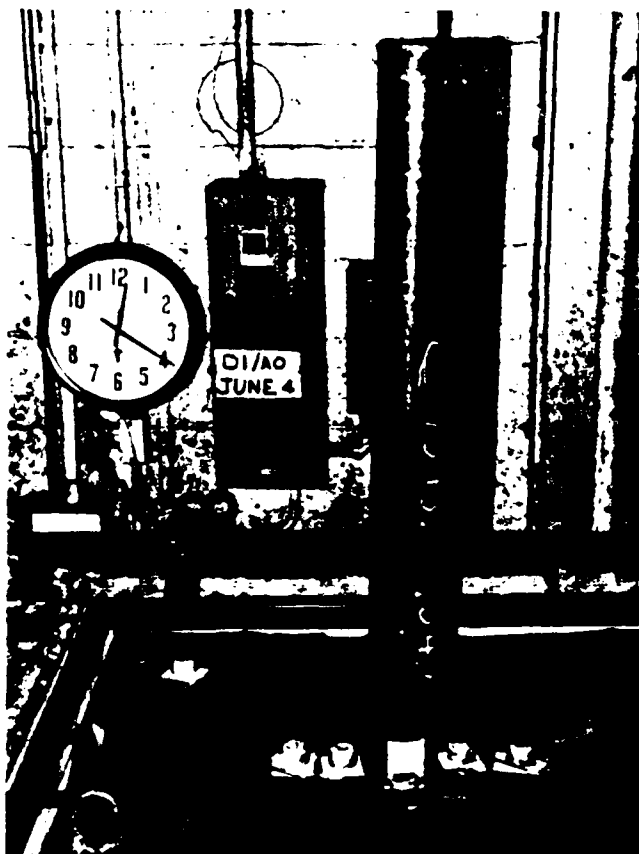
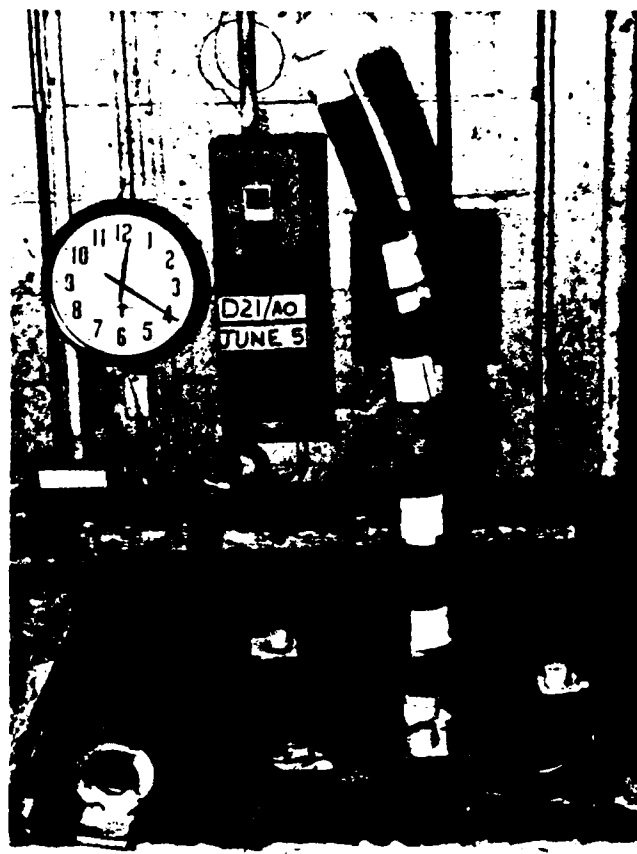
Top Left: Steel Pipe
Bottom Left: Ventilation Duct
Top Right: Electrical Cable

- Piping penetration details similar to those shown in U.S. Coast Guard Navigation and Vessel Inspection Circular No. 6-80 and Canadian Coast Guard standard sketches (References 2 and 3)
- Electrical cable penetration details similar either to designs already approved by the U.S. Coast Guard and listed in CG-293 or to designs shown in Canadian Coast Guard standard sketches. (Reference 4)

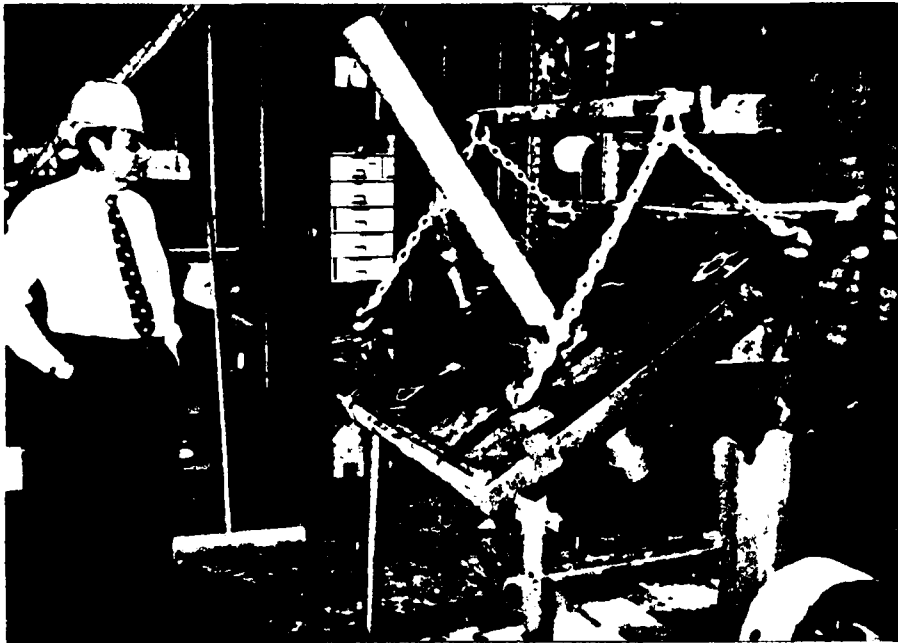
Figure 2. Class A-0 and Class A-60 Construction

Class A-0

Class A-60

The U.S. Coast Guard and the Canadian Coast Guard selected and designed the penetrating items and firestop systems. The items consisted of standard construction materials and represented standard firestop systems used in penetrating shipboard Class A-0 and Class A-60 decks and bulkheads. The penetrating items included various combinations of steel pipes, copper pipes, PVC pipes, ventilation ducts, and electrical cables. The firestop systems included steel plate, bronze plate, and proprietary fire resistant sealant and devices. The samples were manufactured by Davie Shipbuilding Limited in Quebec, Canada. They were delivered to Underwriters Laboratories in Chicago, Illinois, with each penetration item in a 36-inch x 36-inch x 3/16-inch (91.4 cm x 91.4 cm x 0.5 cm) thick steel plate. All sample construction was representative of Class A-0 construction. The UL staff secured insulation (rockwool batts) to the fire side of the steel plates and penetrating items to prepare Class A-60 deck assemblies. The rockwool batts complied with the Class A-60 structural insulation requirements of 46 CFR 164.007 (Reference 1). The attachment of the batts to the penetrations and assemblies is described in Appendix C.

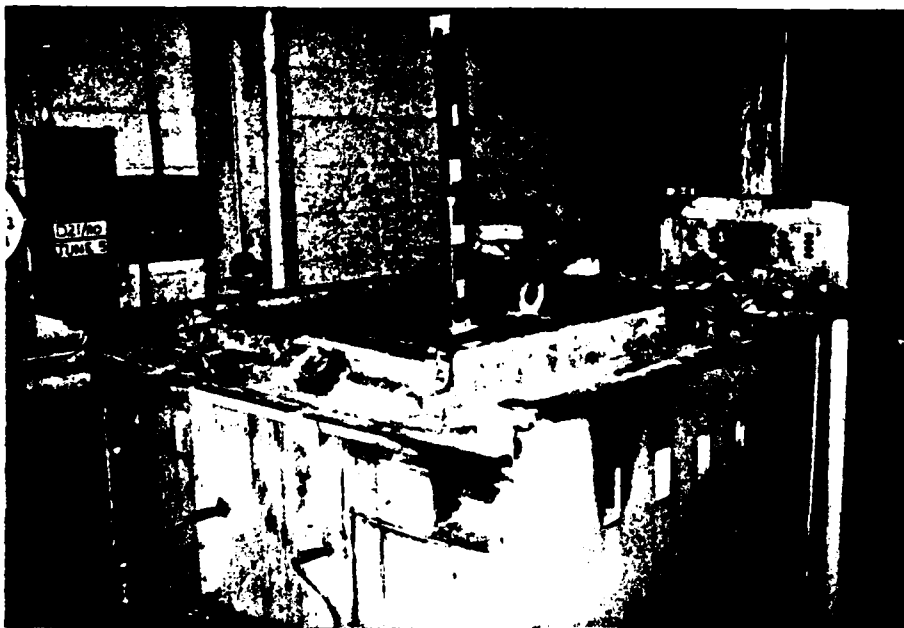
Figure 3. Test Furnace

Furnace Controls and Data Recording Equipment

Penetration Sample Being Tested in Furnace

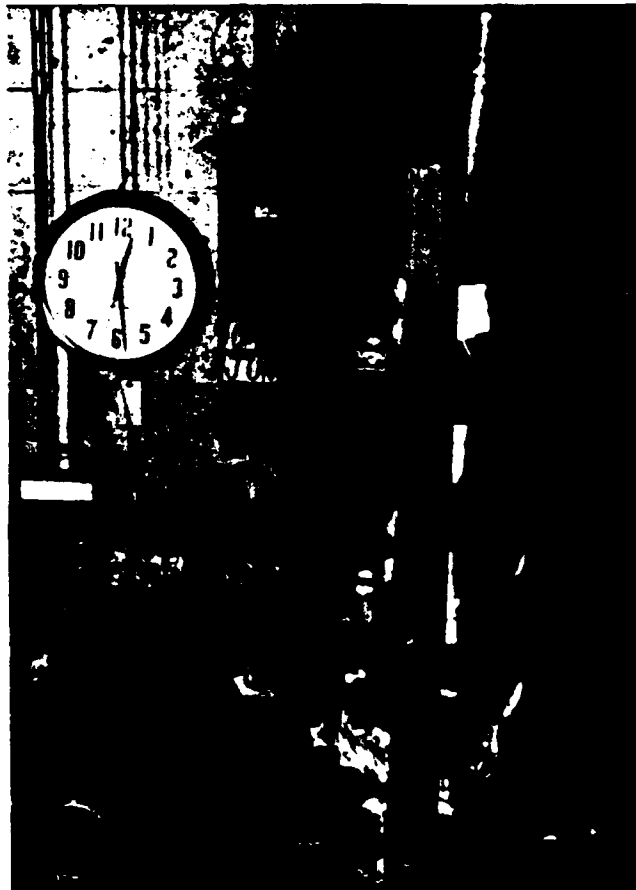
Figure 5. Class A-O Test Failure

Sample D14/AO

Only penetration samples D14 and D19 failed the Class A-0 exposure test. Twenty-five minutes into the test the PVC penetration (D14) was issuing heavy amounts of smoke on the unexposed side of the penetration assembly. At twenty-eight minutes it ignited and began to burn, Figure 5. Forty-four minutes into the test, the penetrant had collapsed and the test was terminated. Because the penetrant had collapsed during the fire test, the hose stream test was not conducted. Fifteen minutes into the test the multiple electrical cable penetration (D19) was issuing heavy smoke from the base of the cable jackets on the unexposed surface. By thirty-one minutes

Observations recorded for penetration samples D14 and D19 during the Class A-0 exposure tests do not indicate that an opening occurred which permitted the passage of smoke and flame through the samples. However, smoke and flame were observed on the nonexposed side of the penetration assemblies. This is a failure according to Coast Guard regulations for Class A-0.

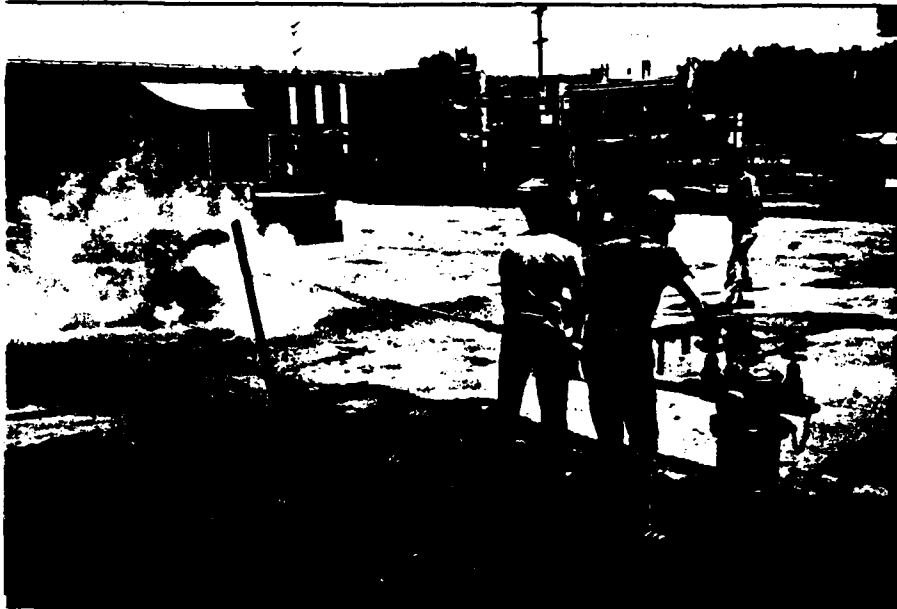
Figure 19. Hose Stream Results

Hose Stream Test

Insulation After Hose Stream

Only penetrations D4, D6, D8, D10, D12, D17, and D20 failed the heat transmission test for the insulated samples. Temperatures on these penetrants or test assemblies were recorded above acceptable limits. Figure 11 shows two insulated penetrations. The ambient temperature inside the area where the penetrations were stored was measured at 80°F (27°C). Figures 12 through 18 reflect temperature plots for the penetrations which failed the heat transmission test. Figure 19 shows the hose stream test and an insulated penetration after the hose stream test.

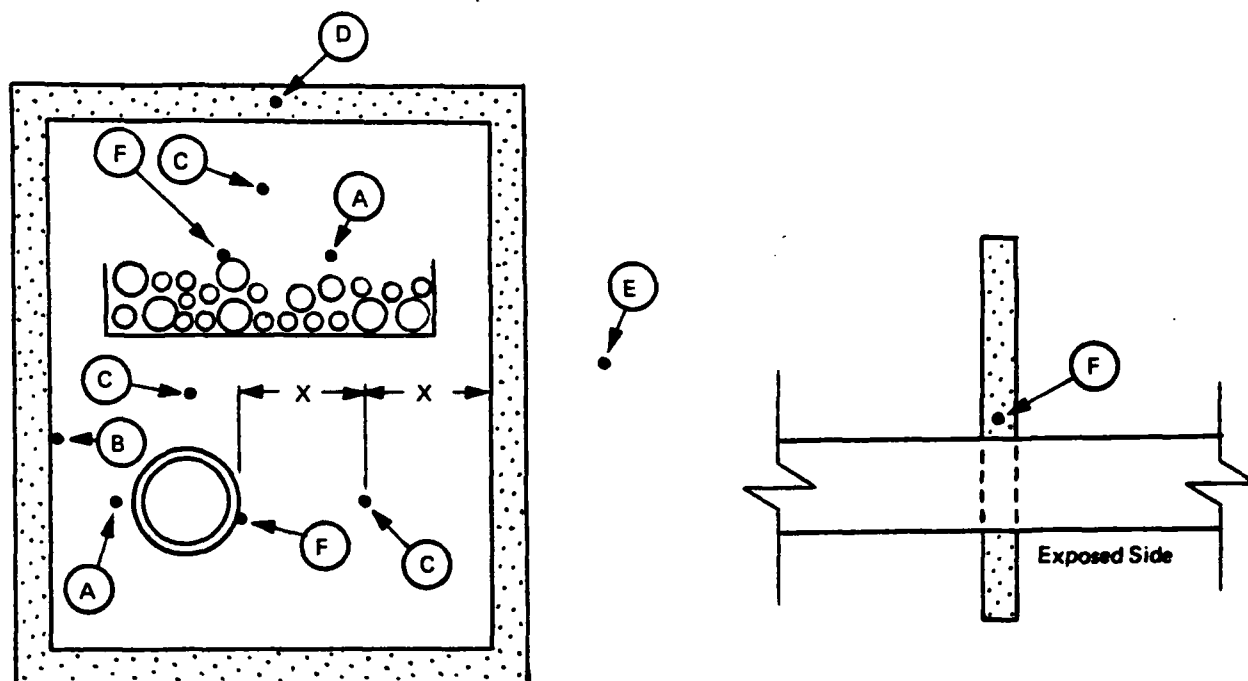
FIGURE 4.2
TEMPERATURE MEASUREMENT LOCATIONS^a

^a See paragraph 4.14 for description of letter symbols

4.16 Temperatures on the surface of the through-penetration firestop and test assembly are to be measured with thermocouples placed under flexible pads (see paragraph 4.19). The pads are to be held firmly against the surface and are to fit closely about the thermocouples. Each thermocouple junction is to be located under the center of each pad. The thermocouple leads under the pads are to be not larger than No. 18 AWG (0.82 mm²) and are to be electrically insulated with heat- and moisture-resistant coverings.

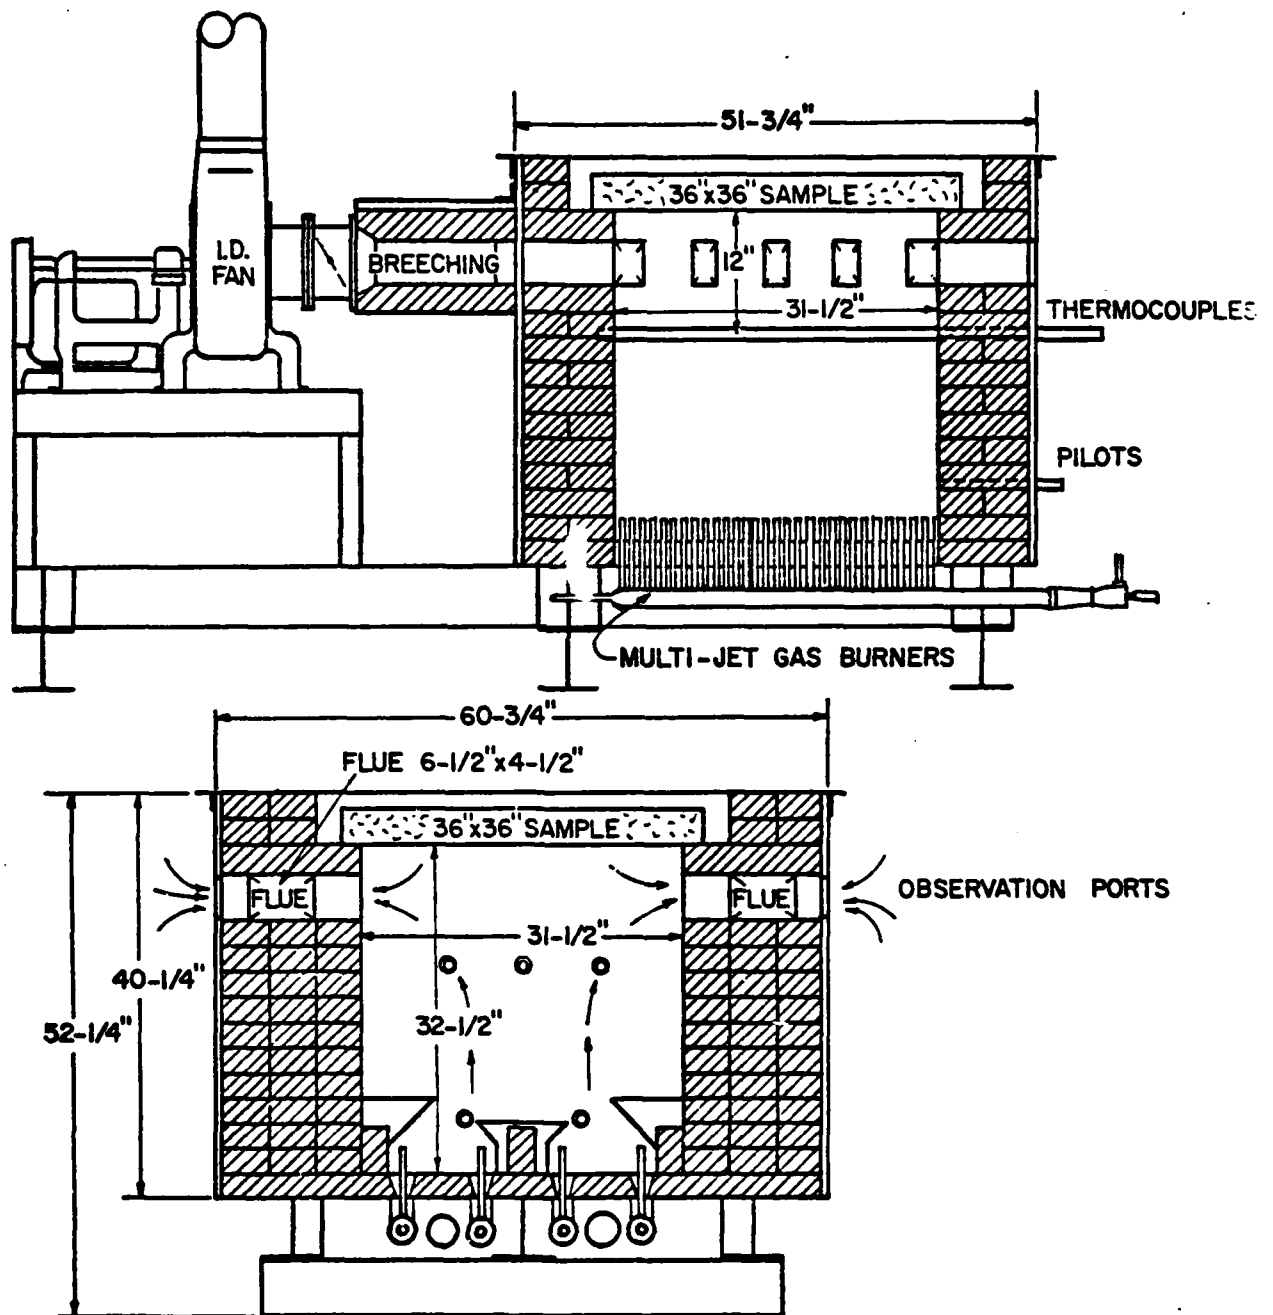
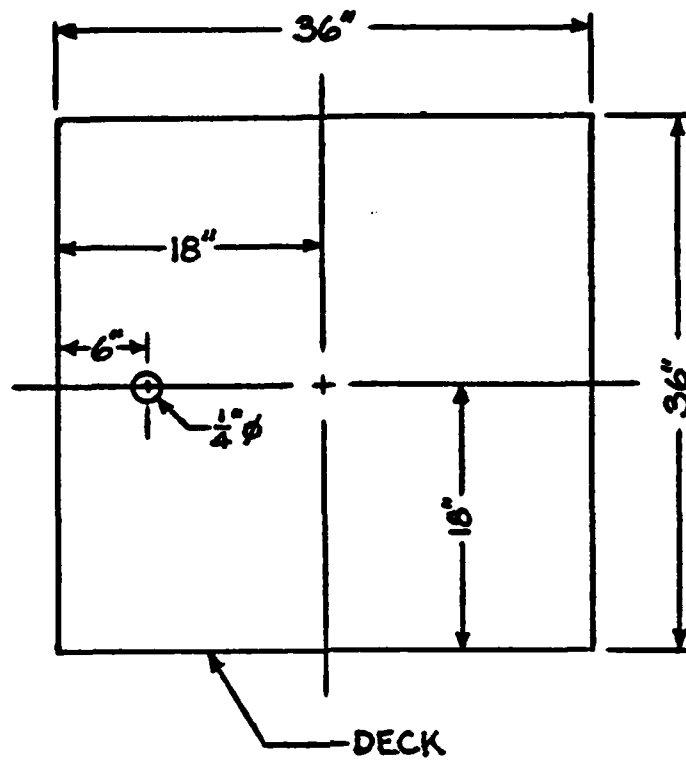
SMALL SCALE HORIZONTAL EXPOSURE FURNACE

PRESSURE DIFFERENTIAL PROBE LOCATIONS

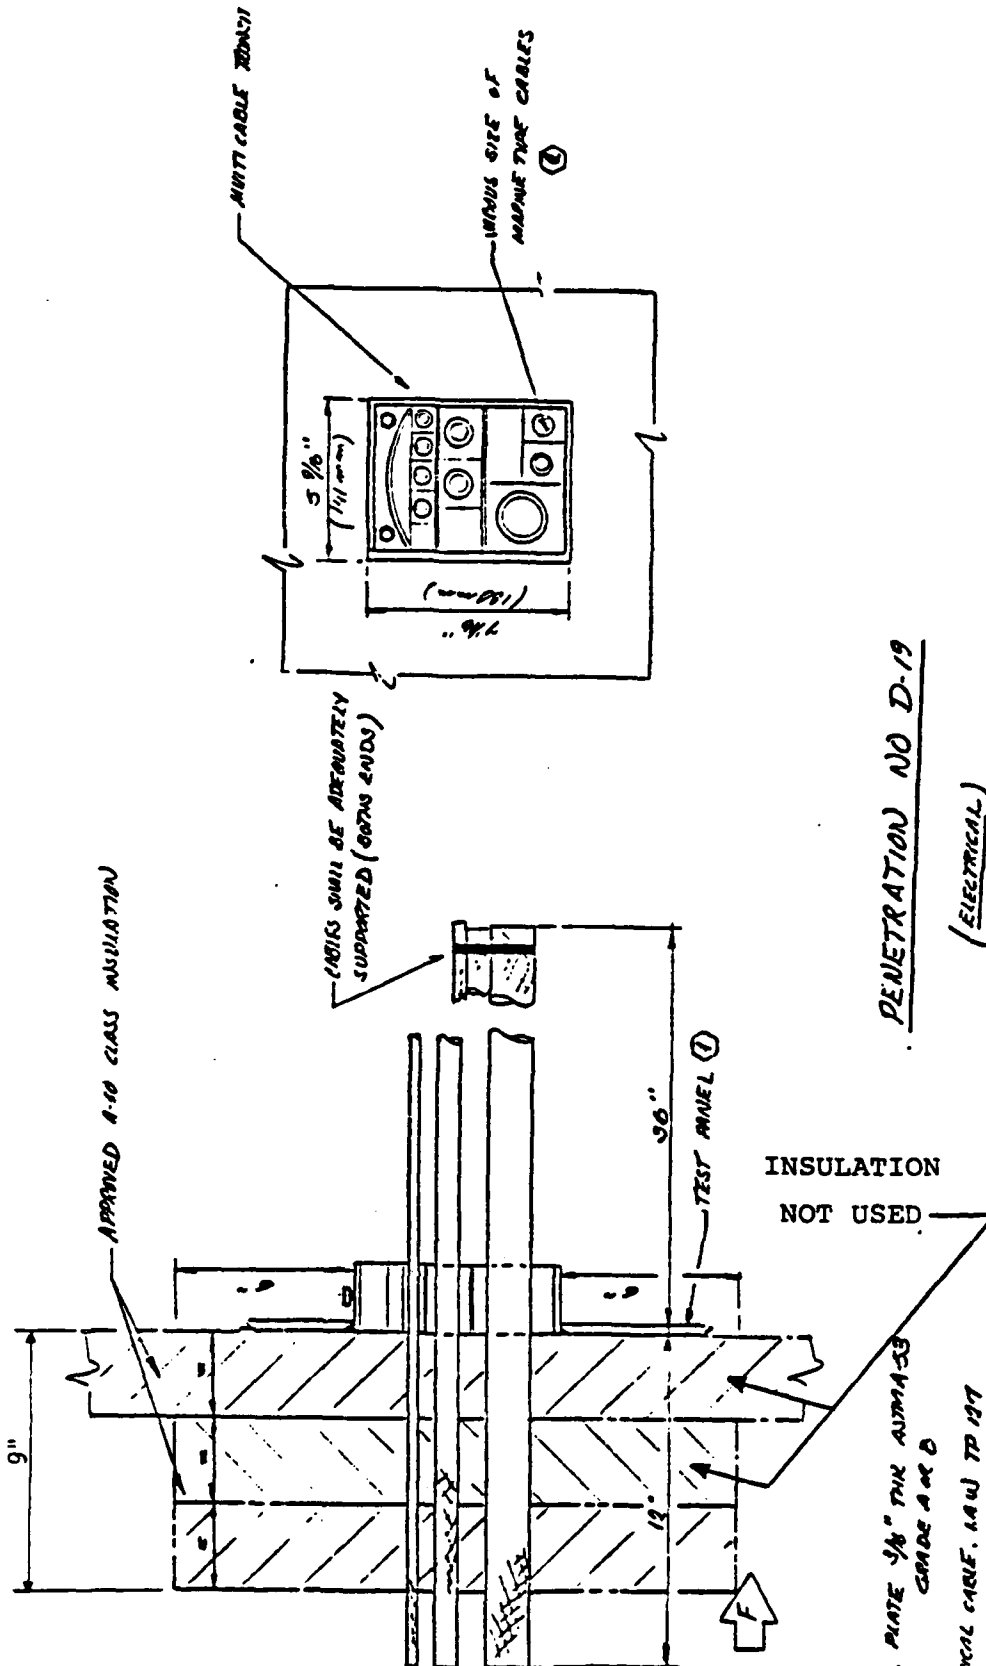
ASSEMBLY D-19/A0
 JUNE 12, 1984

CABLE TYPE "1", No Marking - 37 Strands - 3c
 CABLE TYPE "2", Philips 3c 14 AWG XLPE 750V (35c)
 CABLE TYPE "3", 00/00 AWG/3 Canada Wire Mari XBl 750 Volt 1983
 CABLE TYPE "4", No Marking - 3c
 CABLE TYPE "5", Brand-Rex Kana-Tane PRXT 20k 12 AWG 600V
 CABLE TYPE "6", Brand-Rex Polyrad XT 20/c 10 AWG 600 V 125 c°

PENETRATION NO D-19
 (ELECTRICAL)

Penetration D19 - The multiple cable transit extended through a 3/16-inch (0.5 cm) steel plate and failed the Class A-0 fire tests by permitting the occurrence of flame and smoke on the unexposed side of the sample. It appeared that the cable on the unexposed side of the sample caught fire because of the heat radiating through the steel deck surrounding the cable transit. Nine inches (22.9 cm) of approved structural insulation extending down the penetrant's fire exposed side provided a Class A-60 fire rating.
